DPF Cleaning Report

Customer:	Unipart	Order Number:	
Depot:	Crawley	Ceramex Reference:	ST000005236
Mileage:	120,000	Serial No:	58919
Vehicle Details:	BMW LC 57	Date:	14/10/2013

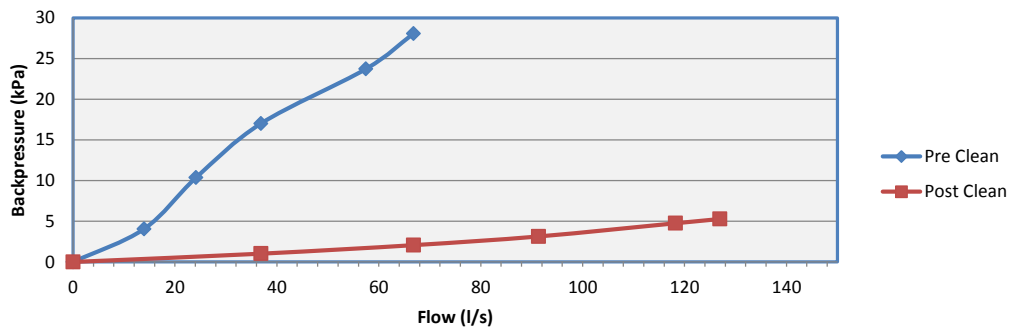
Airflow / Backpressure Curve

Back Pressure Testing In kilopascal (kPa) @ 50l/s

Before Clean

14.6

After Clean

1.4

The dpf was very well loaded with soot and ash. Post testing points to a very clean dpf with the system working well.
